**Greenbank Beach and Boat Club, Inc.**

**Shoreline Permit Application No. 312/16  
ICC Chapter 17.05A.110.B.7 Evaluation of Impacts  
of 2016 Boat Ramp Repair Work**

**Greenbank, Washington**

**March, 2017**

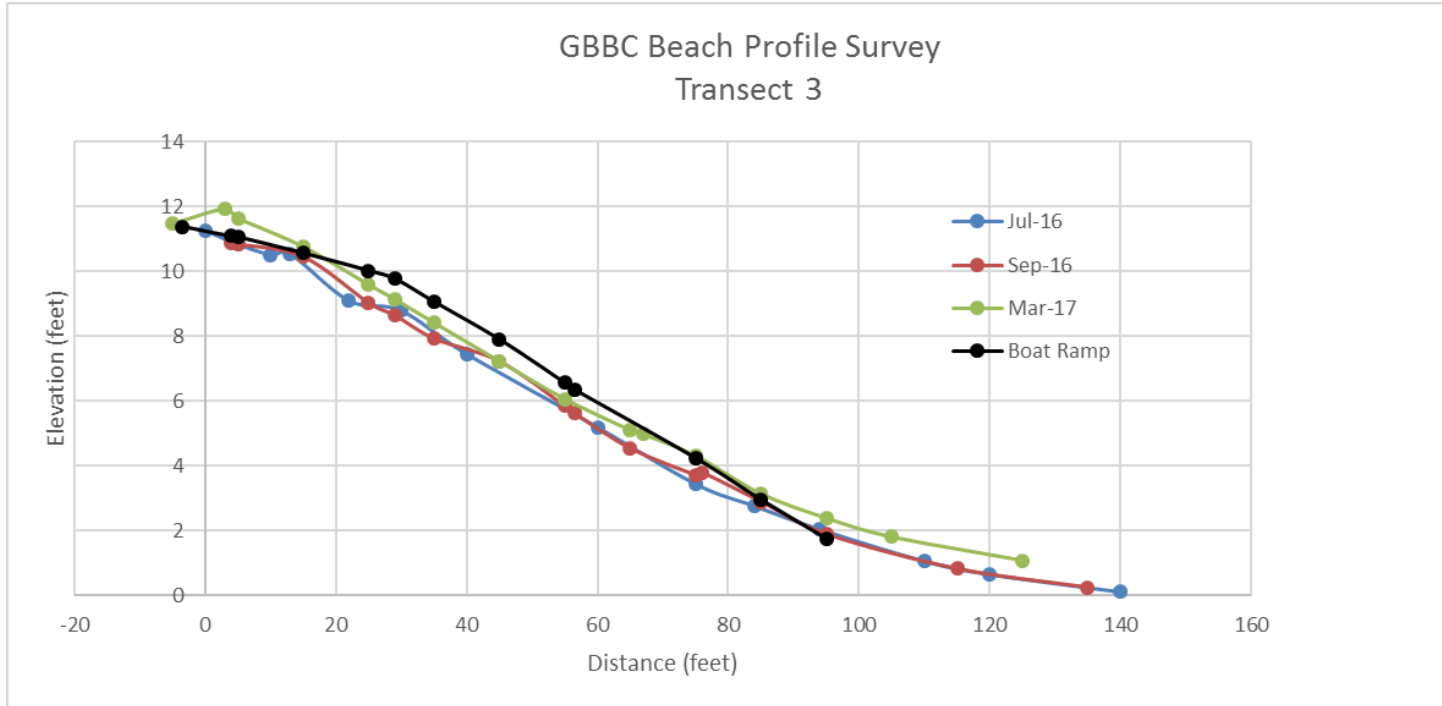
The change in the beach profiles between July 2016 and March 2017 on the south (Transect 3) and the north (Transect 4) sides of the boat ramp is illustrated in the following two plots.

The general trend for both plots is that the beach profile gradually aggrading and filling in, relative to the ramp surface, with the maximum difference between the ramp and the beach on the south side decreasing from about one foot to about 6 inches and the difference on the north side decreasing from about 2 feet to about 18 inches. As described in Section 3.1, the beach profiles can vary with particular storm and wind conditions: for example, the greatest difference between the beach and the north side of the ramp as shown in the December 2016 photo in Figure 3 is considerably less than 18 inches, but it grew to about 18 inches in March 2017.

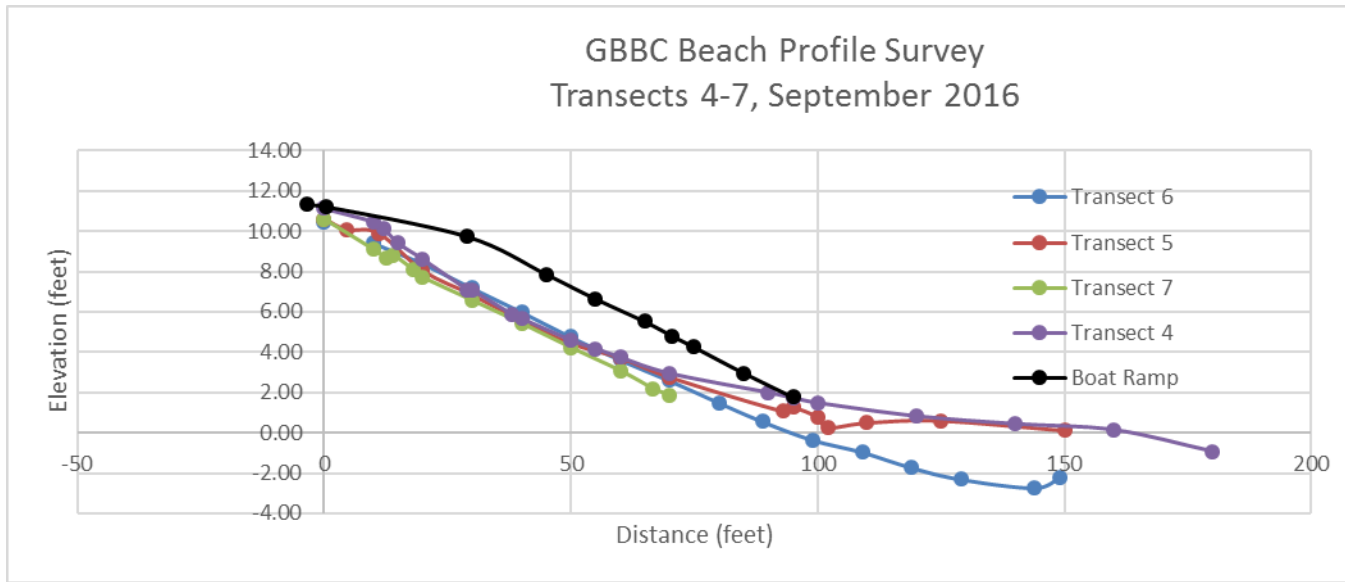
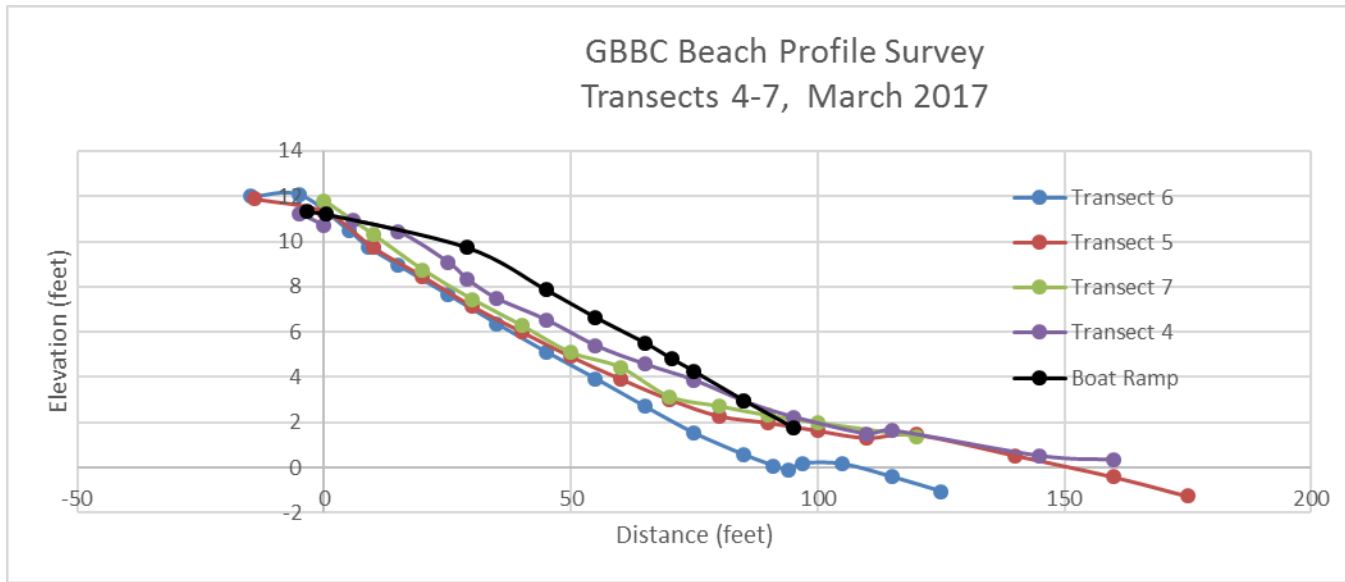
A similar trend of the beach profile gradually filling in can be seen in the other transects located immediately down-drift of the ramp. The two data plots below show profiles at Transects 4, 5, 6, and 7 as surveyed in September 2016 and March 2017. Over the winter, the profile at Transect 6 (the furthest west of the boat ramp) was relatively stable, while Transects 4, 5 and 7 each rose.

The trends shown in the beach profile data plots indicate that beach sediment continues to move from the south to the north along the shoreline, either around or over the boat ramp, especially during the winter storm season. Beach aggradation is greatest at the bottom of the ramp, which is consistently covered with gravel, and at the upper end of the ramp, above the MHHW elevation, where over one foot of gravel had accumulated in March 2017.
