Greenbank Beach and Boat Club, Inc.

**Shoreline Permit Application No. 312/16
ICC Chapter 17.05A.110.B.7 Evaluation of Impacts
of 2016 Boat Ramp Repair Work**

Greenbank, Washington

March, 2017

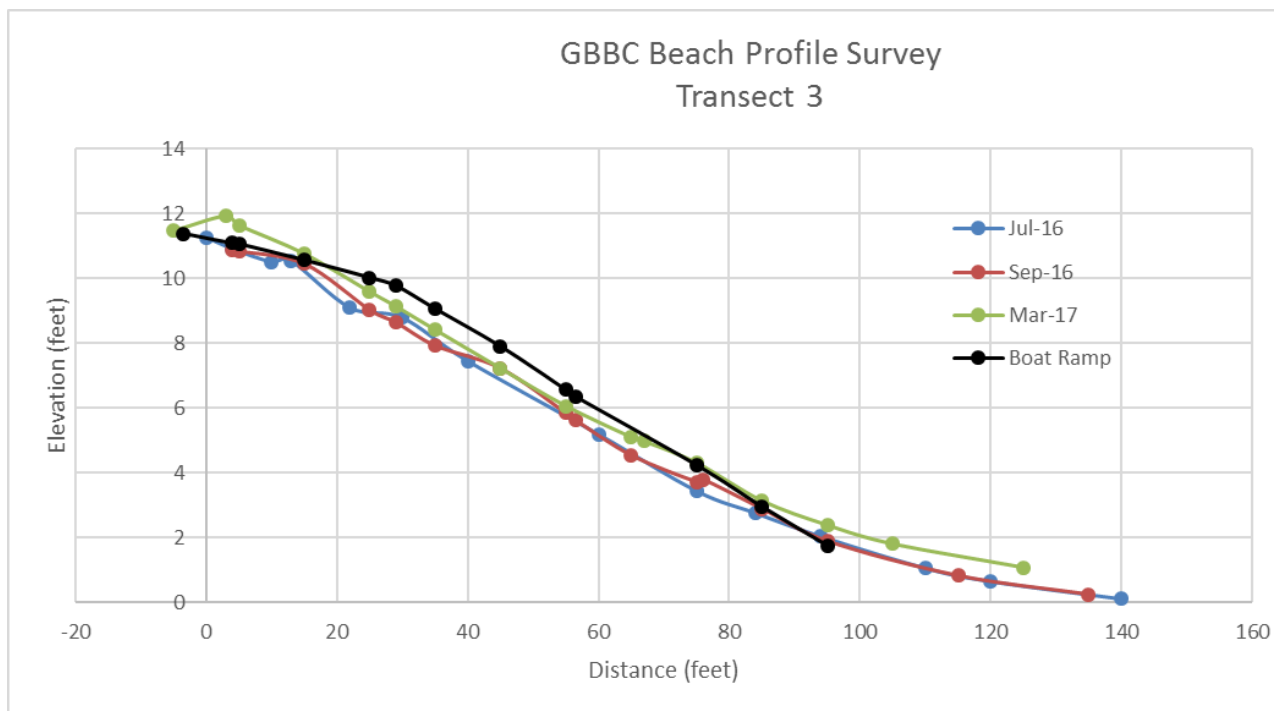
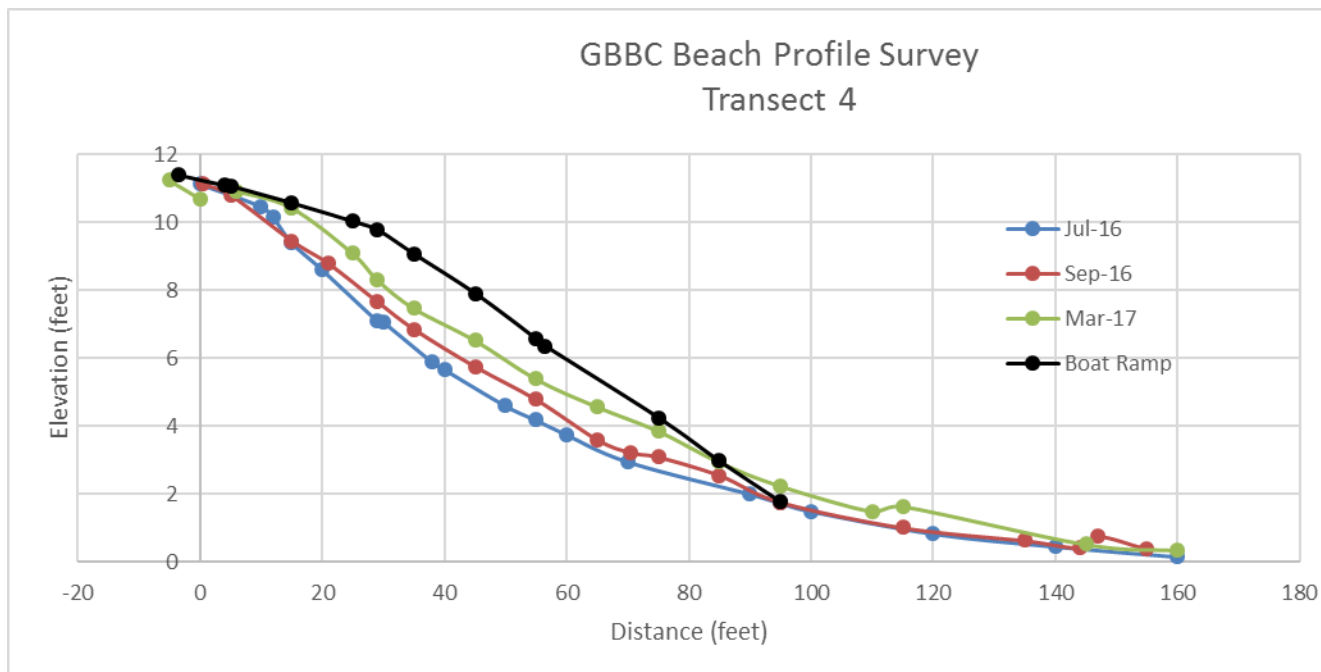
The change in the beach profiles between July 2016 and March 2017 on the south (Transect 3) and the north (Transect 4) sides of the boat ramp is illustrated in the following two plots.

The general trend for both plots is that the beach profile gradually aggrading and filling in, relative to the ramp surface, with the maximum difference between the ramp and the beach on the south side decreasing from about one foot to about 6 inches and the difference on the north side decreasing from about 2 feet to about 18 inches. As described in Section 3.1, the beach profiles can vary with particular storm and wind conditions: for example, the greatest difference between the beach and the north side of the ramp as shown in the December 2016 photo in Figure 3 is considerably less than 18 inches, but it grew to about 18 inches in March 2017.

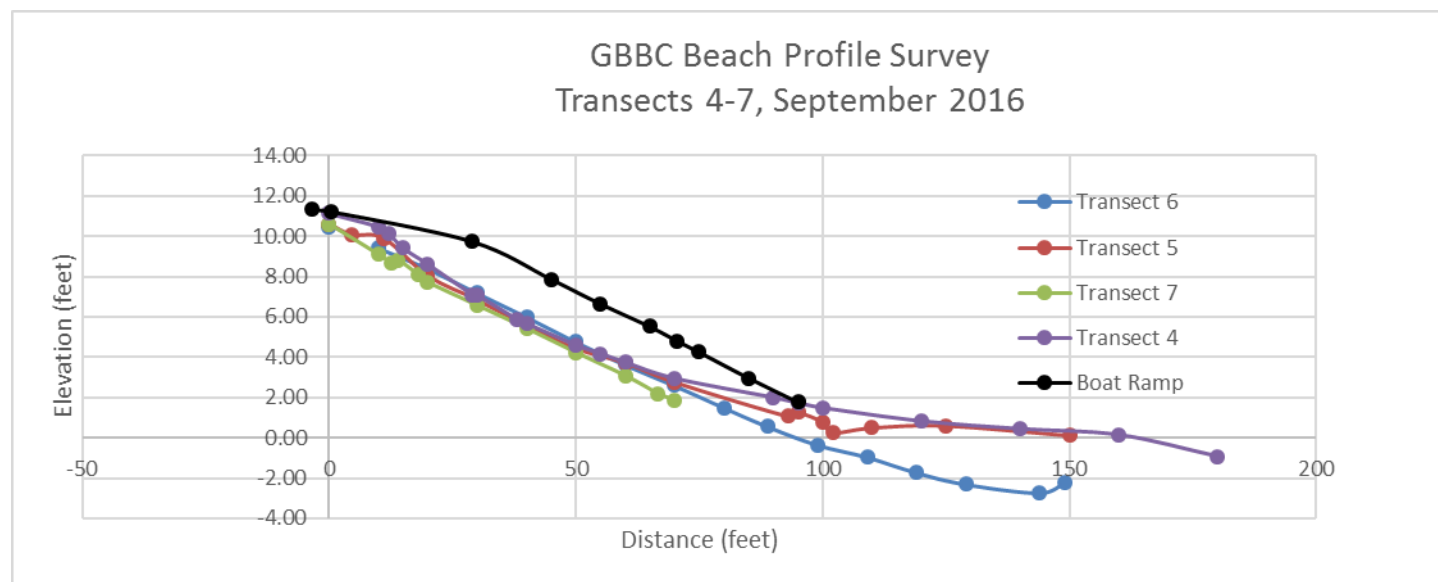
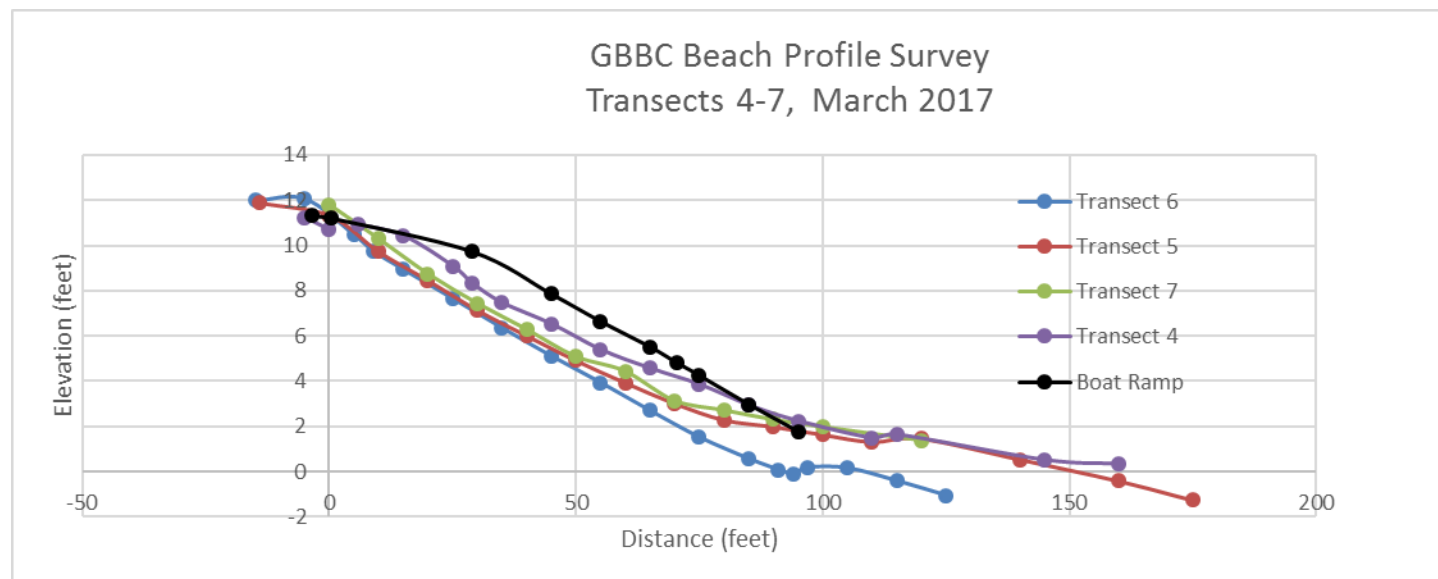
A similar trend of the beach profile gradually filling in can be seen in the other transects located immediately down-drift of the ramp. The two data plots below show profiles at Transects 4, 5, 6, and 7 as surveyed in September 2016 and March 2017. Over the winter, the profile at Transect 6 (the furthest west of the boat ramp) was relatively stable, while Transects 4, 5 and 7 each rose.

The trends shown in the beach profile data plots indicate that beach sediment continues to move from the south to the north along the shoreline, either around or over the boat ramp, especially during the winter storm season. Beach aggradation is greatest at the bottom of the ramp, which is consistently covered with gravel, and at the upper end of the ramp, above the MHHW elevation, where over one foot of gravel had accumulated in March 2017.

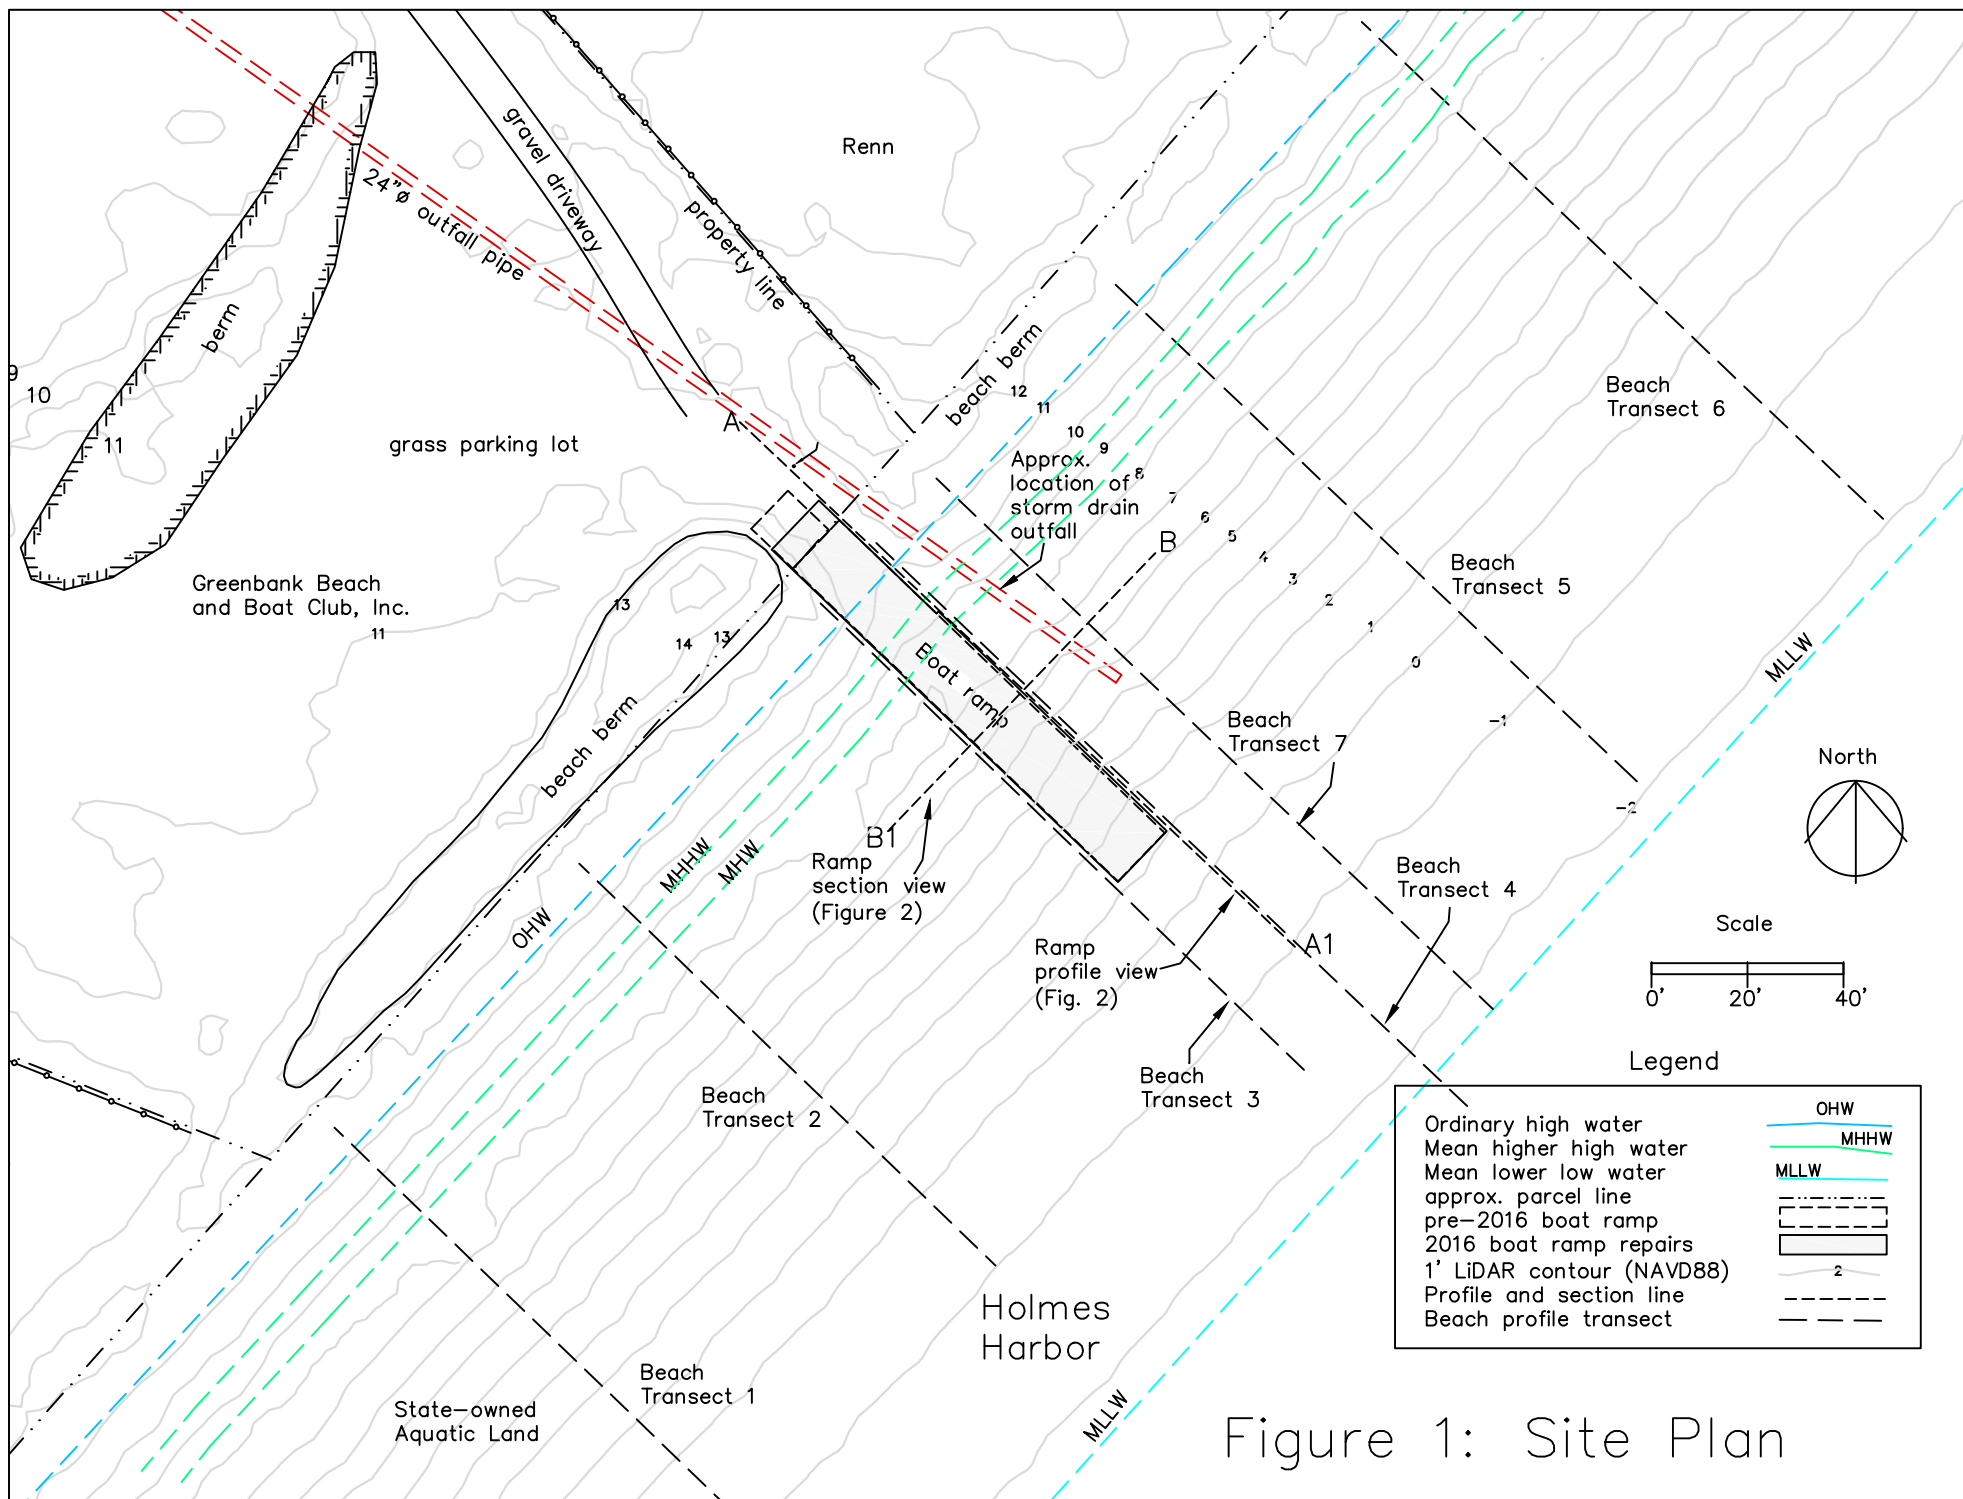
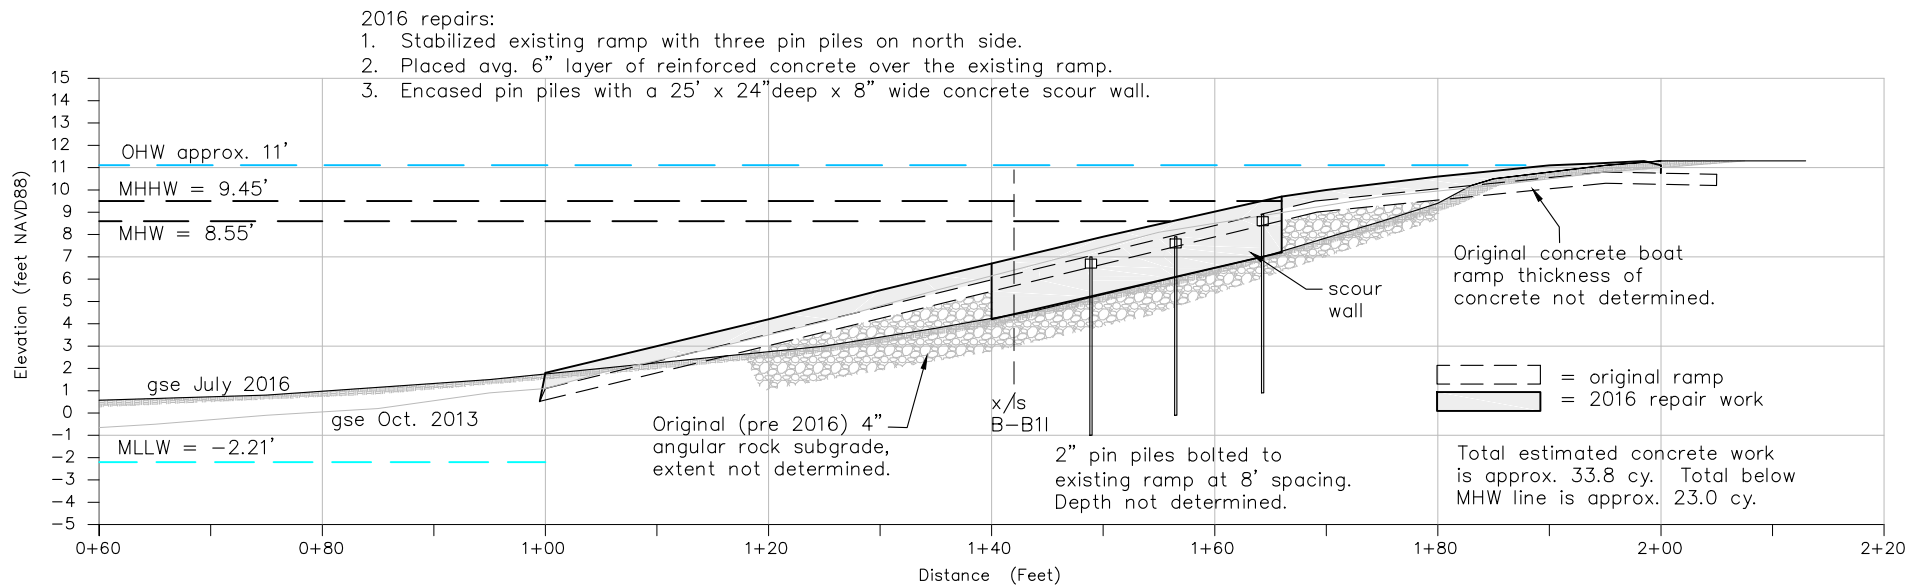
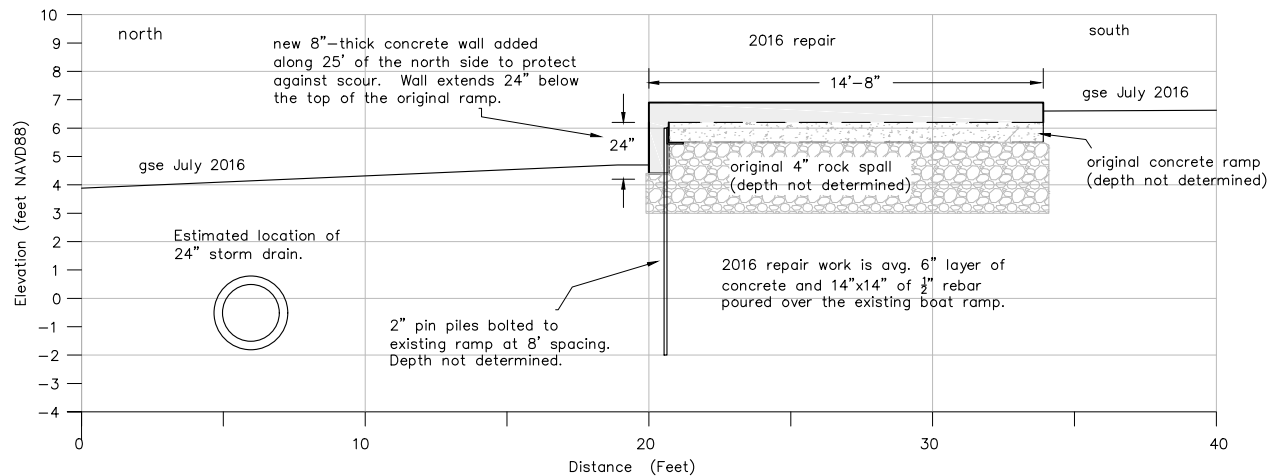
Figure 2: Boat Ramp As-Built Drawings

As-built conditions of the repaired boat ramp were measured in July 2016 for use in comparing changes to the baseline measurements that were completed by WICD in 2013. The 2016 repairs expanded the footprint of the "baseline" boat ramp by increasing the width of the ramp from 14'-0" to 14'-8" along the lower 66 feet of the north side of the ramp. This expansion increased the total surface area of the ramp by 3.2 percent relative to the baseline condition. The work also raised the elevation profile of the ramp by up to 8 inches relative to the baseline surface, with the surface at the top end of 2106 ramp at 11.06' NAVD88 (compared to 10.74' in the baseline condition) and the surface at the bottom end of the ramp at 1.77' (compared with 1.14' in the baseline condition). The length of the 2016 ramp did not

change from the baseline condition. Figure 2 shows as-built drawings of the 2016 repair work. Figure 3 shows a view of the ramp in July 2016.

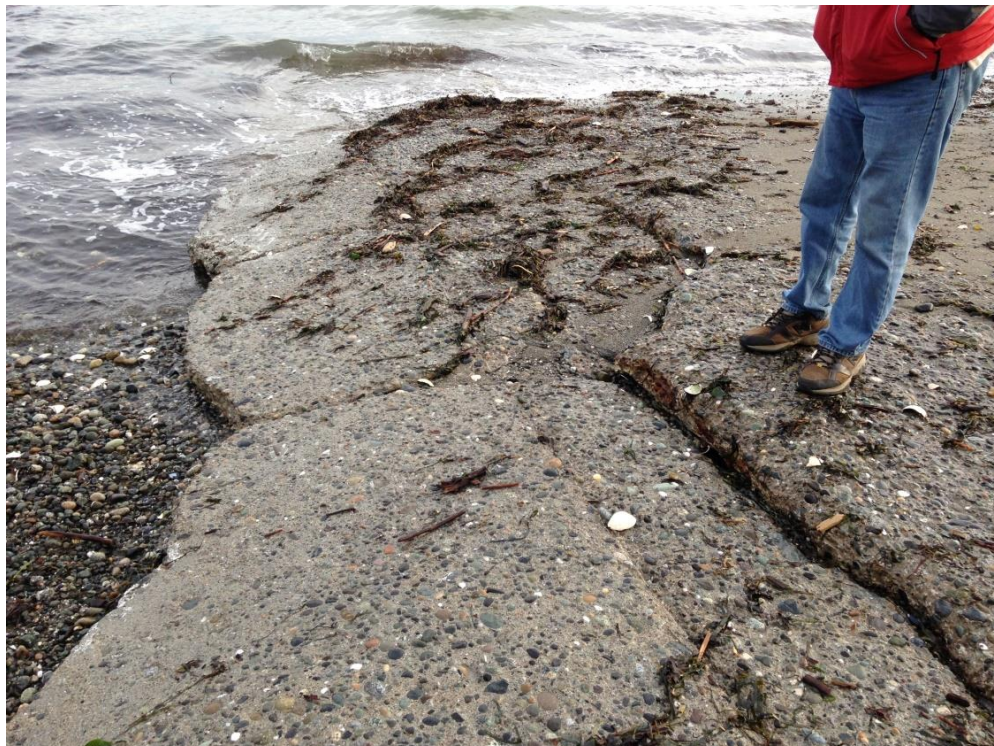
The boat ramp, which was originally constructed in the late 1940s, was severely damaged by a winter storm in December 2015 and further damaged by a second storm in January 2016. Storm-related erosion undermined part of the ramp, which caused that part of the ramp to disintegrate and collapse. GBBC officers believed that the damage was likely to worsen in subsequent winter storms and could result in further unsafe conditions and negative environmental impacts to the beach, and, consistent with ICC 17.05A.110.B.21, decided it was obligated to promptly repair the damage.

Ramp Damage, January 2016

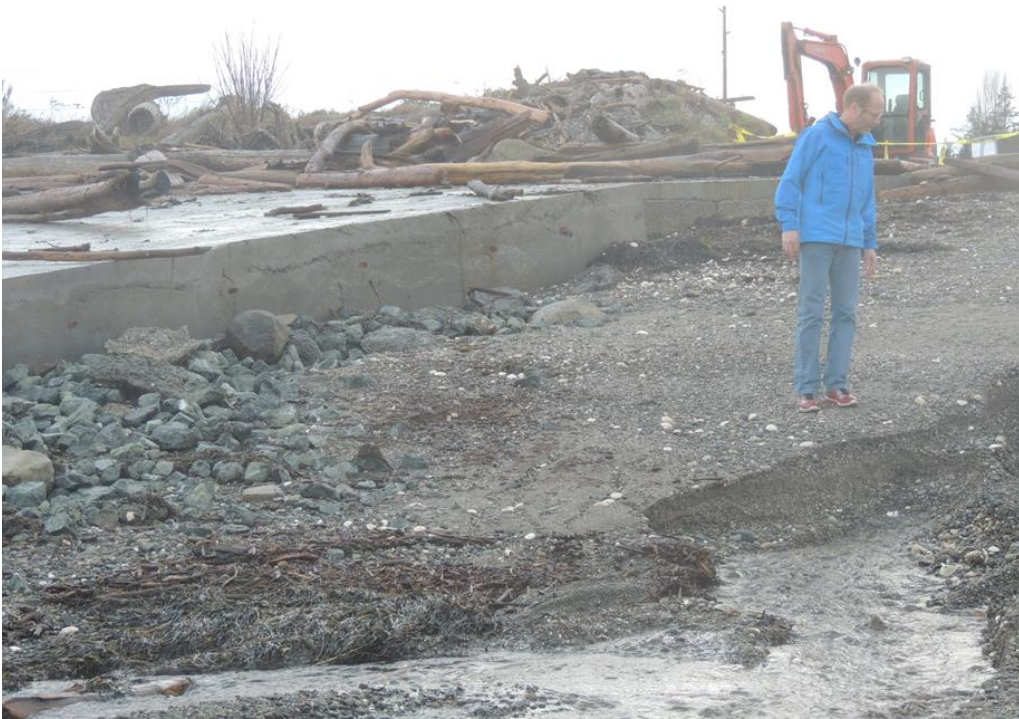
Repaired Ramp, February 2016

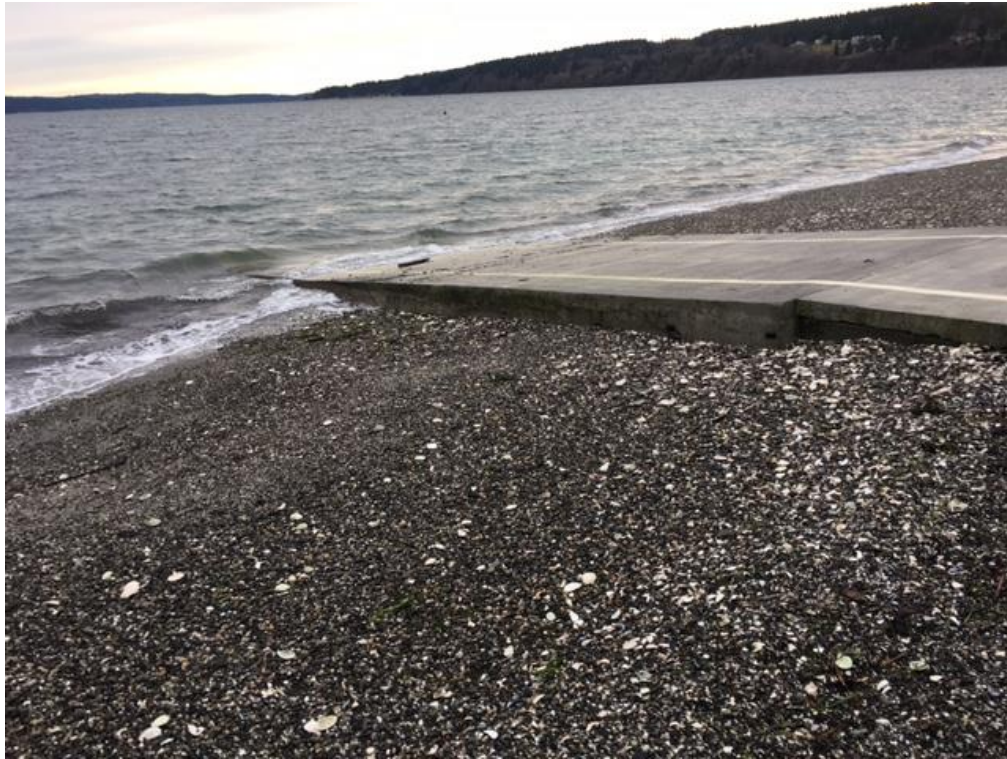
North Side of Ramp, January 2016

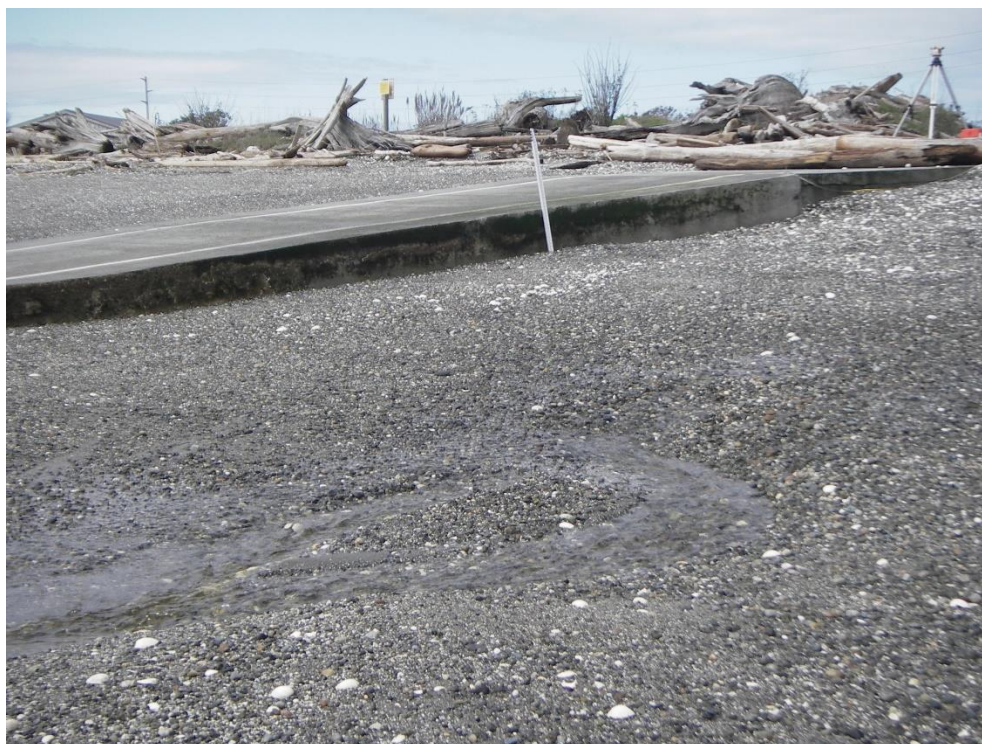
The baseline gravel “delta” feature associated with the stormwater outfall (described in Section 2.2, above) persisted in the post-construction beach transect surveys, suggesting that this feature is primarily related to the presence of the stormwater outfall, and that the 2016 boat ramp repairs did not have a significant effect on it.

North Side of Ramp with Storm Outfall in Foreground, March 2017

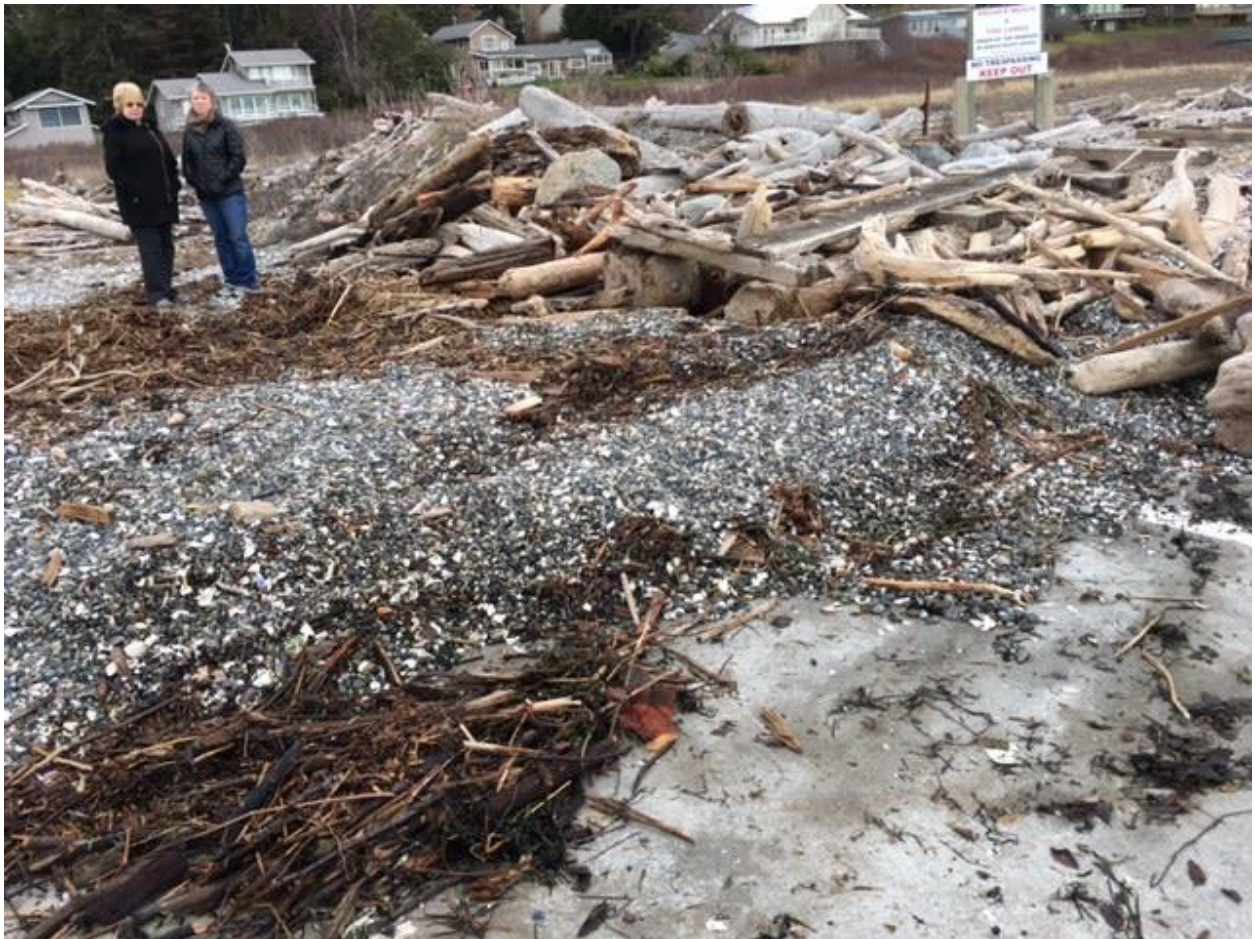
Figure 14: Drift Wood and Sediment Accumulation January 2017

Figure 14 shows drift wood deposited on the boat ramp and back beach areas following a storm in January 2017. Drift wood accumulated as far inland as the existing old cobble dike located west of the GBBC parking area. Observations during winter of 2016-2017 indicate that drift wood continues to accumulate along the upper beach, both up drift (south) and down drift (north) of the boat ramp, in similar abundance as it did in the baseline condition (GBBC, personal communication).
