Greenbank Beach and Boat Club, Inc.

**Shoreline Permit Application No. 312/16
ICC Chapter 17.05A.110.B.7 Evaluation of Impacts
of 2016 Boat Ramp Repair Work**

Greenbank, Washington

March, 2017

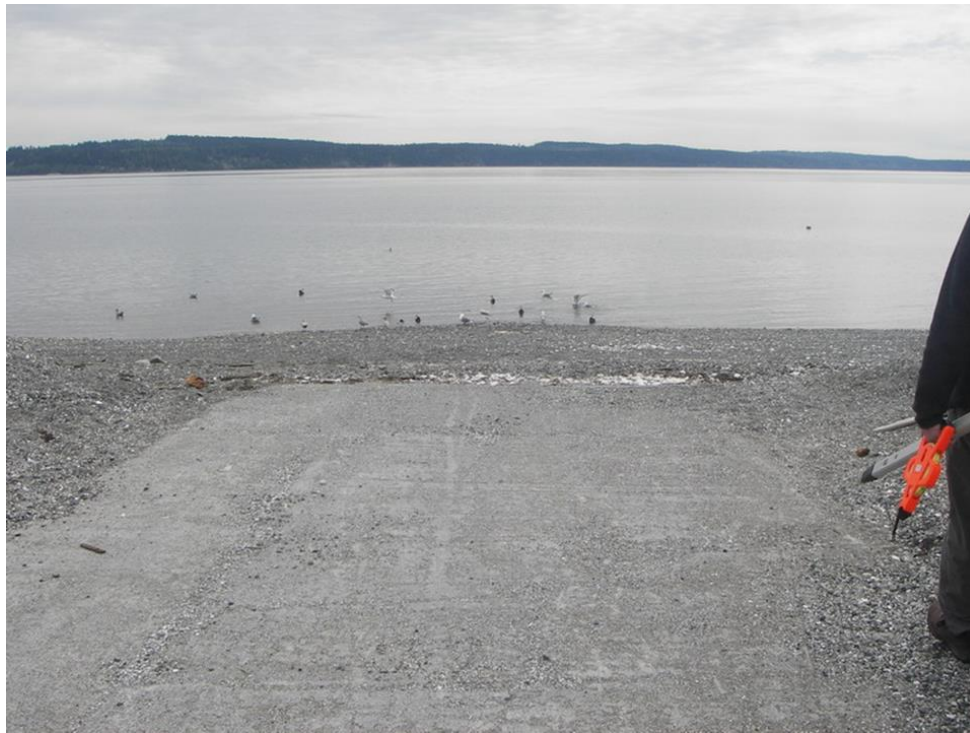
Boat Ramp in October 2013

In the 2013 baseline condition, the boat ramp extended 100 feet from the edge of GBBC’s parking area to a natural slope break on the gravel beach. In 2013, the ground surface elevation (GSE) at the top of the ramp was 10.74’ NAVD88² and the GSE at the base of the ramp was 1.14’. The beach slope break at the bottom of the ramp represents roughly the boundary between the upper beach and the lower sand flats. The flats then slope gradually to deep water in Holmes Harbor. For reference, the Mean Higher High Water (MHHW) tide elevation at the site is estimated to be 9.38’ NAVD88 and the Mean Lower Low Water (MLLW) tide elevation is estimated to be -2.21’.³ The October 2013 baseline width of the ramp was 14.0 feet. At that time, the ramp surface was approximately at grade with the beach. Figure 3 shows a view of the boat ramp in 2013.

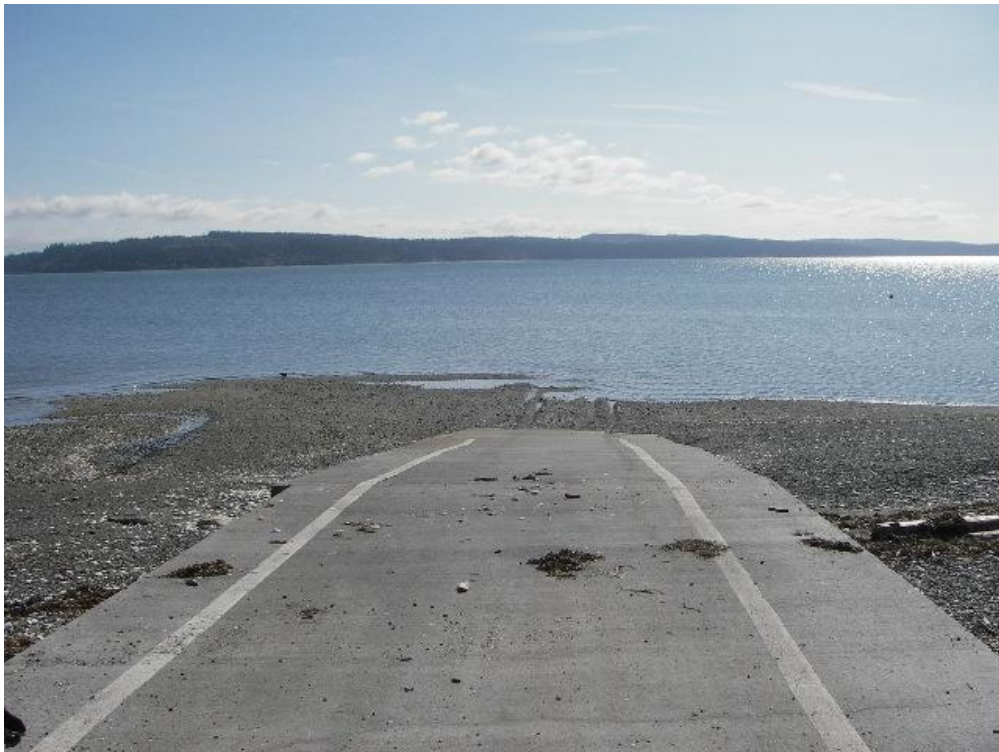
Boat Ramp Summer 2016

change from the baseline condition. Figure 2 shows as-built drawings of the 2016 repair work. Figure 3 shows a view of the ramp in July 2016.

The general trend for both plots is that the beach profile gradually aggrading and filling in, relative to the ramp surface, with the maximum difference between the ramp and the beach on the south side decreasing from about one foot to about 6 inches and the difference on the north side decreasing from about 2 feet to about 18 inches. As described in Section 3.1, the beach profiles can vary with particular storm and wind conditions: for example, the greatest difference between the beach and the north side of the ramp as shown in the December 2016 photo in Figure 3 is considerably less than 18 inches, but it grew to about 18 inches in March 2017.

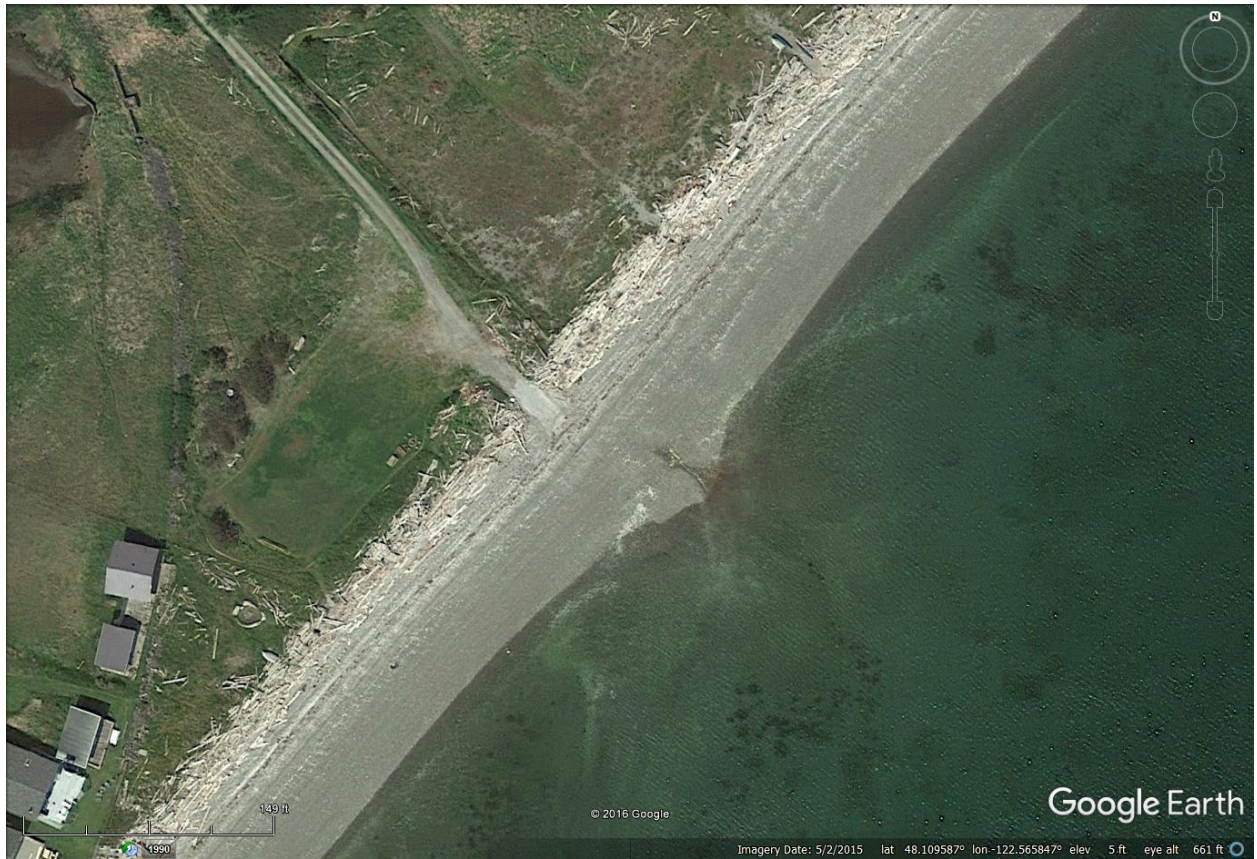
Figure 4: View of Offshore Marine Vegetation Coverage Baseline Condition
(Google Earth Image dated May 2, 2015)

The predominant sediment size class on the upper beach is gravel, which transitions to sand flats below a slope breach at approximate GSE of 1' NAVD88. An exception to the typical beach profile is a slightly elevated gravel "delta", which extends seaward approximately one hundred feet from the end of the boat ramp. It is believed that the formation and persistence of this delta is related to the hydraulic effect of stormwater discharge from an outfall pipe, which is located about 25 feet north (down drift) of lower end of the ramp. A May 2015 satellite image shows the delta extending approximately 40 feet north and south of the centerline of the outfall (Figure 4).

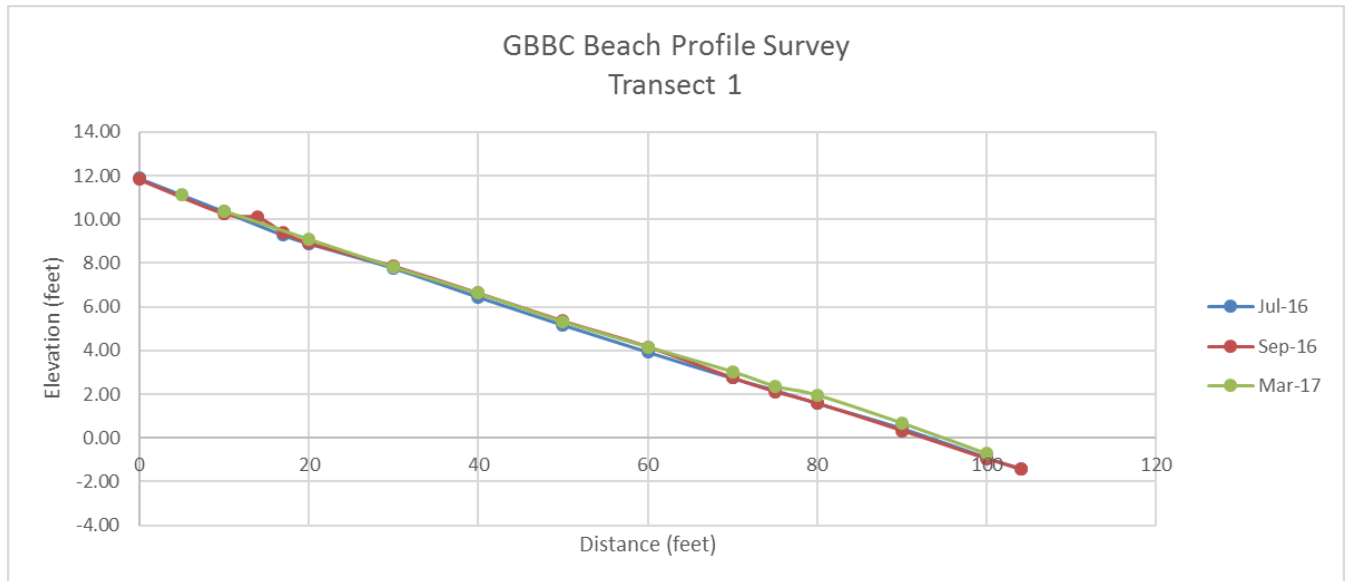
Figure 5: Transect 1

Data points from the three surveys are plotted for each transect in Figures 5-13, with individual plots highlighted for illustration purposes in the text, below. The trend of the data plots shows relatively stable beach profiles at each of the transects between July and September 2016 with a slight increase in elevation along the south (Transect No. 3) and north (Transect No. 4) sides of the boat ramps over the summer. This increase is interpreted as reflecting a modest movement of sediment along the beach from the south to the north during the relatively calm summer months. The rate of net sediment movement during summer appears to be greater lower in the beach profile than at higher elevations on the beach: by the second set of transect surveys (September 2016), the beach surface was at grade with the lower end of the ramp on the south side, and GBBC members reported cleaning two or three wheelbarrow loads of gravel off the end of the ramp during the summer. Gravel movement was also
